Performance of Aluminum Riveted Culvert in California

T.J. Summerson and R.J. Hogan

Center for Technology  
Kaiser Aluminum & Chemical Corporation  
Pleasanton, CA 94566

ZCFT-79-39-TJS/RJH  
NOVEMBER 1, 1979

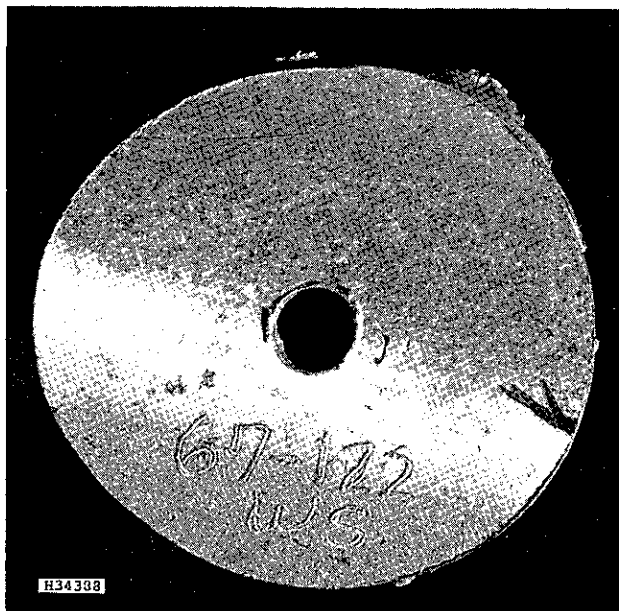
Invert  
From the Inlet End

Water Side: Light staining with several etched  
areas limited to the cladding  
surface

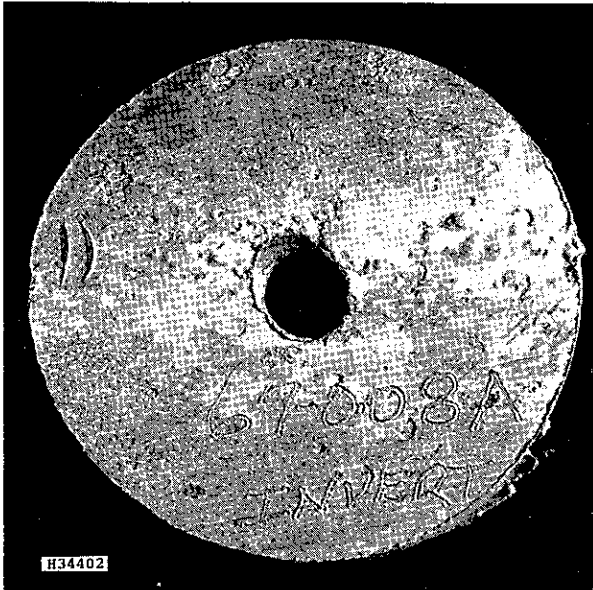
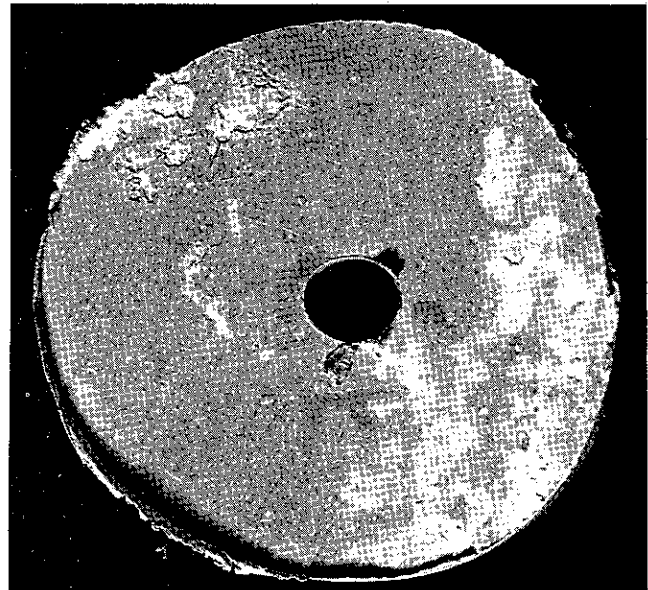
Invert  
West End

Lap Interface: Partially stained,  
no corrosion

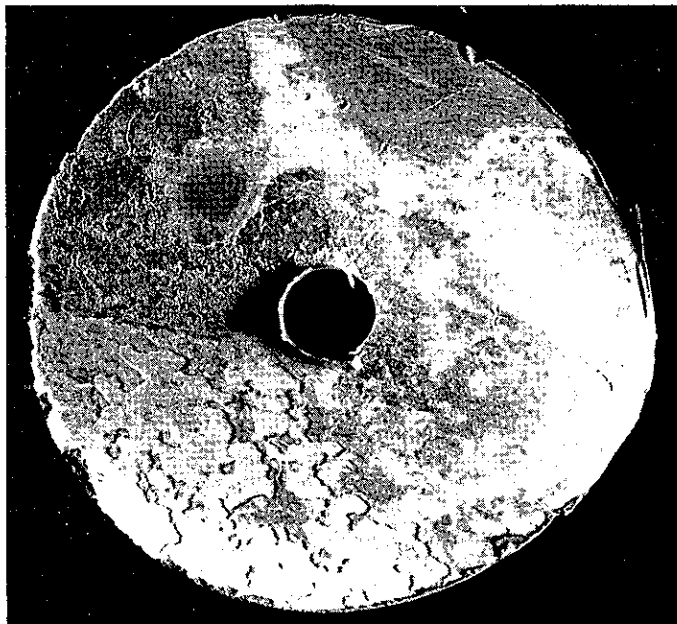
Lap Seam - Invert  
10-Feet from South End

Water Side: No corrosive attack, scratches  
or mechanical abrasion only

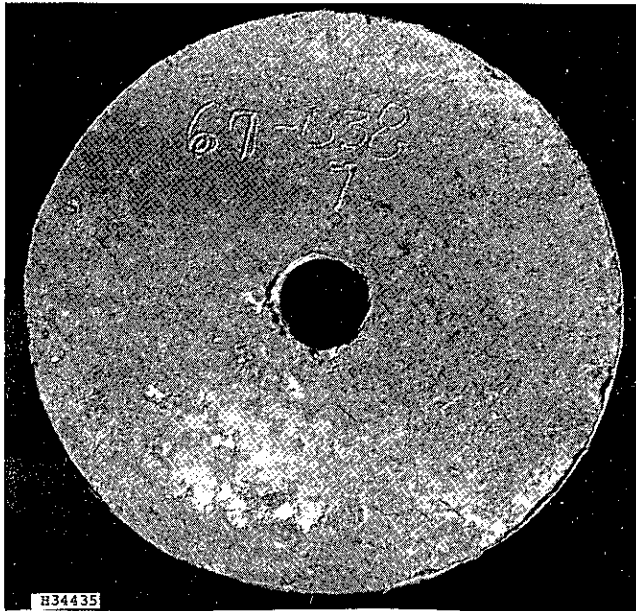
Invert

Water Side: Corrosion of cladding, 0.003 inch

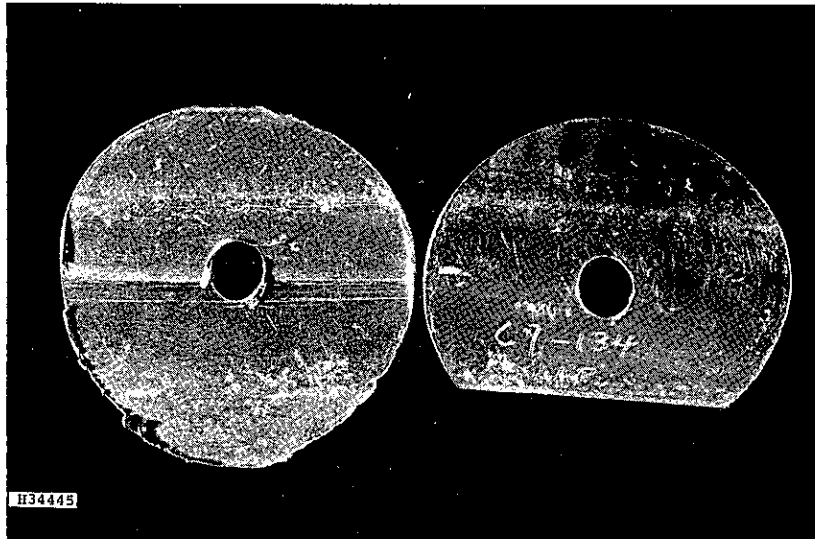
Crown - Lap Interface

Soil Side: Slight surface etching,  
no measurable corrosion

NOTE: Mechanical damage to water side of  
coupon during sampling

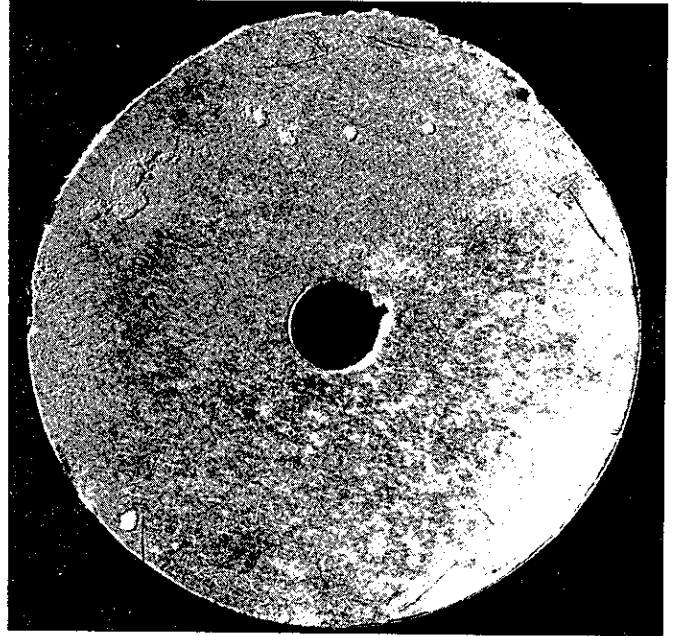
Honch (9 o'clock)  
9-1/2 Feet from Inlet End

Water Side:    No attack

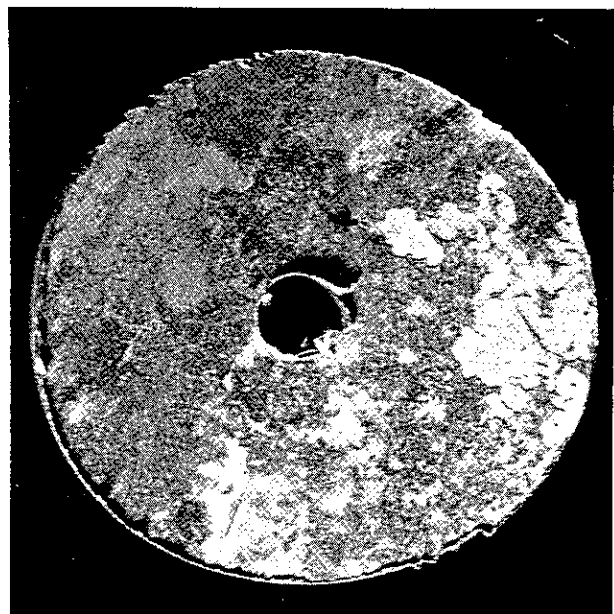
Invert  
20-Feet from Outlet End

Soil Side: Corrosion limited to the cladding  
layer, 0.0038 inch

Water Side: Abrasion of cladding layer  
0.0025 inch deep

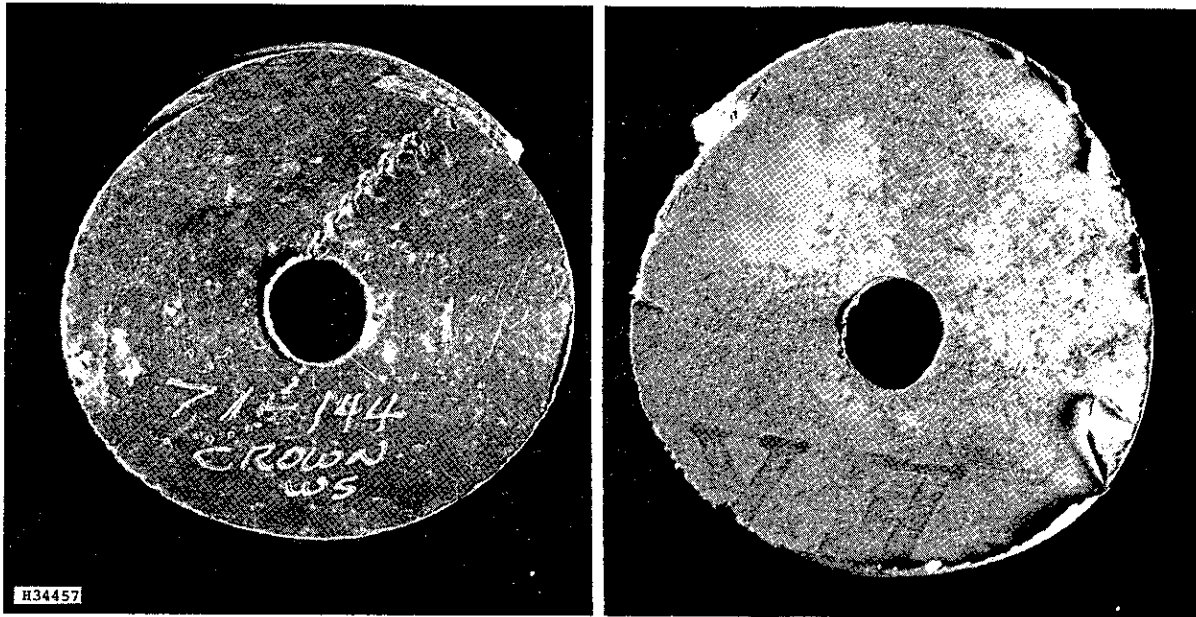
Crown  
31-Feet from Inlet End

Soil Side: Corrosion limited to the cladding  
layer, 0.0038 inch

Water Side: Abrasion of cladding layer  
0.0025 inch deep

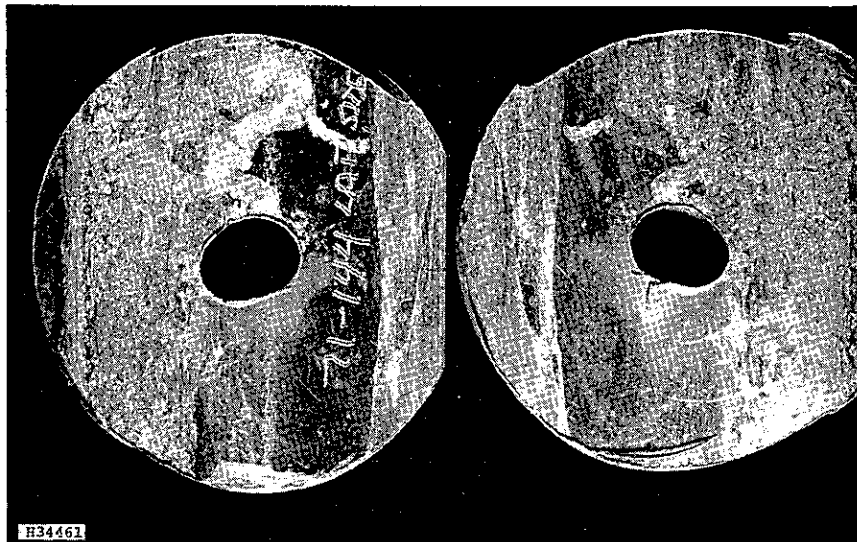
Lap Interface

Water Side: No attack

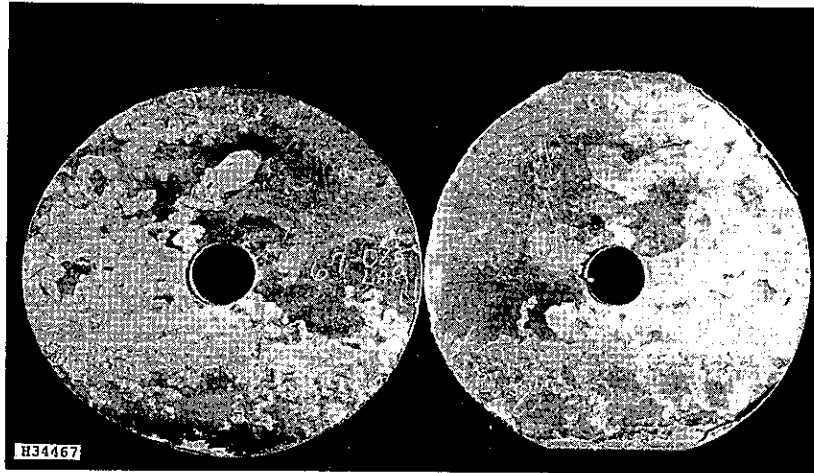
Honch (Lap Interface)

Water Side: Perforated from soil side corrosion

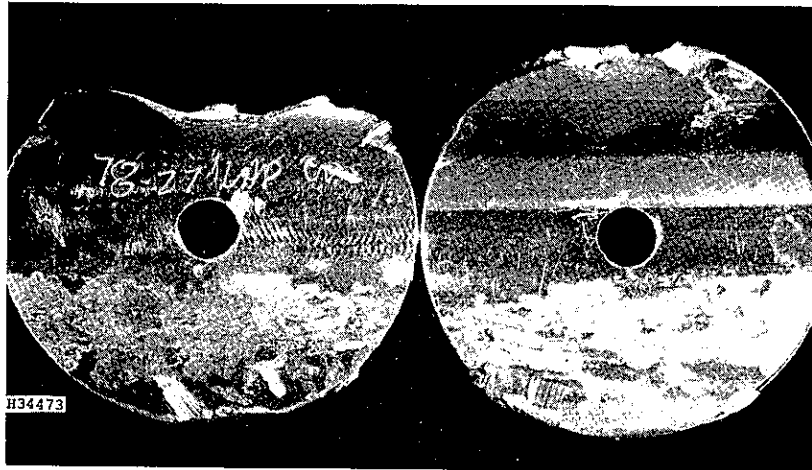
Crown Lap (Interface)

NOTE: Soil was in the water side (culvert  
half full of soil).

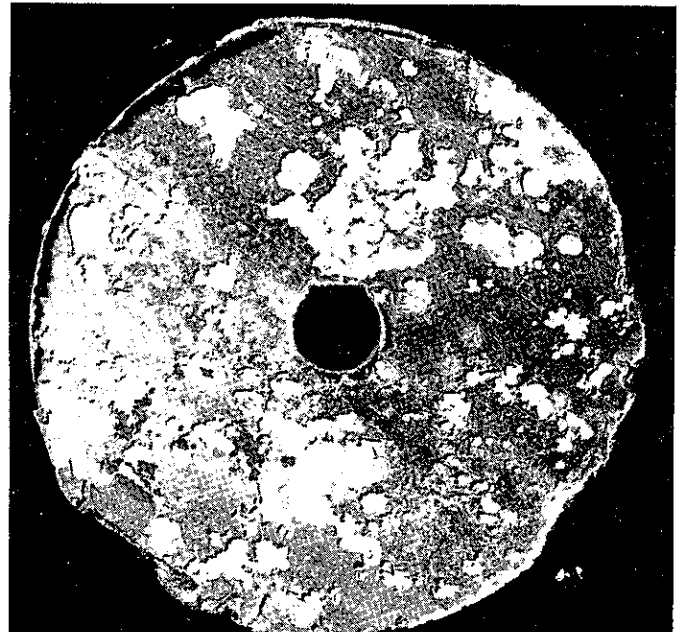
14-1/2 Feet from Inlet End

Lap Interface: Slight staining, no measurable  
attack

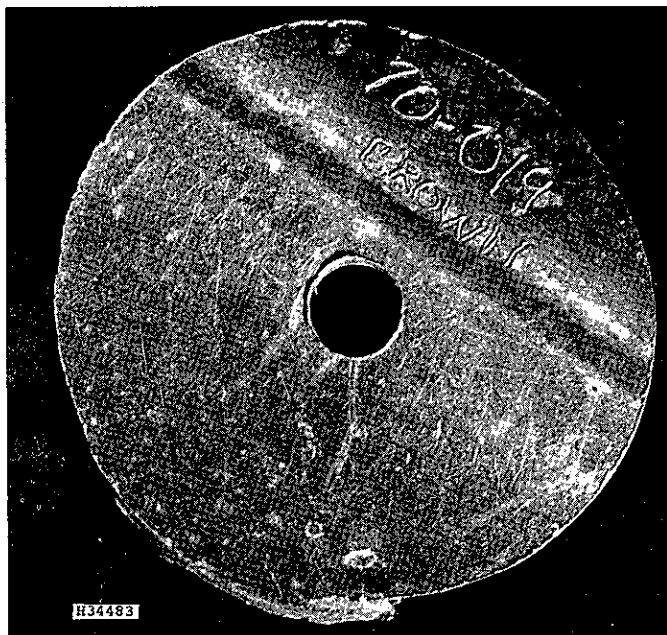
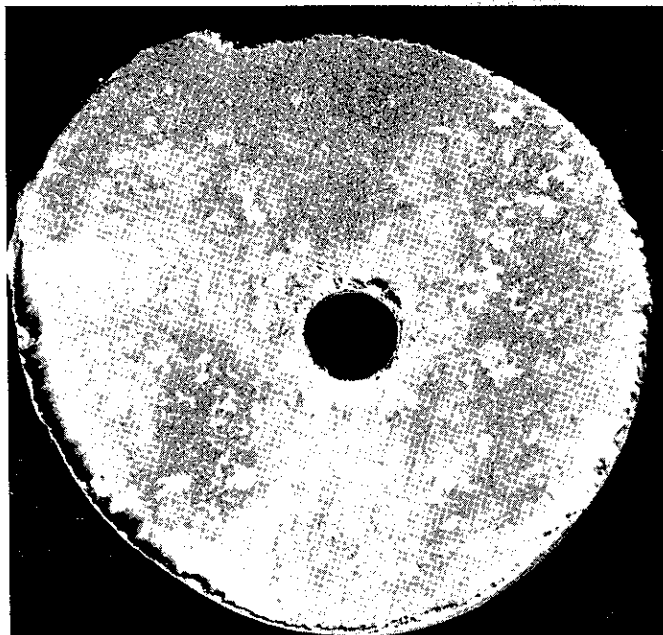
Crown  
10-Feet from Inlet End

Soil Side: Perforations and large areas of  
invert corroded away, from soil  
side corrosion

Water Side: Severe corrosion from soil side

Note: pH is below 4.0

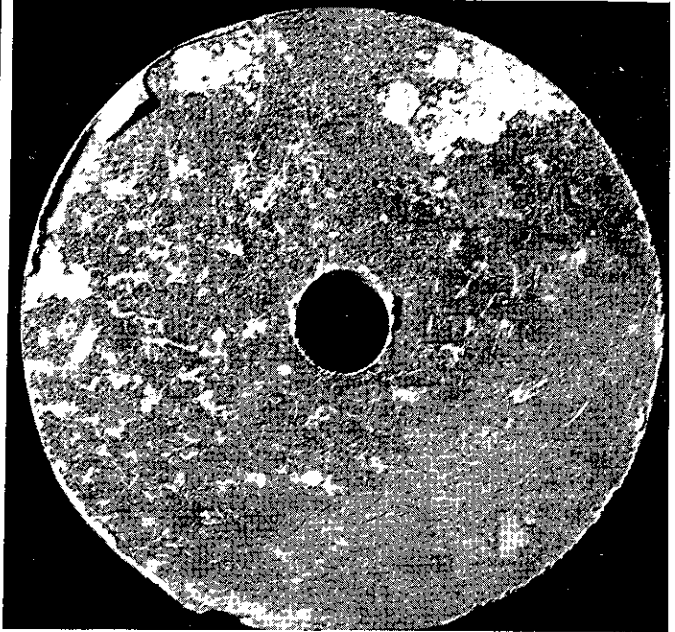
Invert  
23-Feet from Inlet End

Photo and visual inspection show culvert  
was extremely dirty and appears to be in  
excellent condition

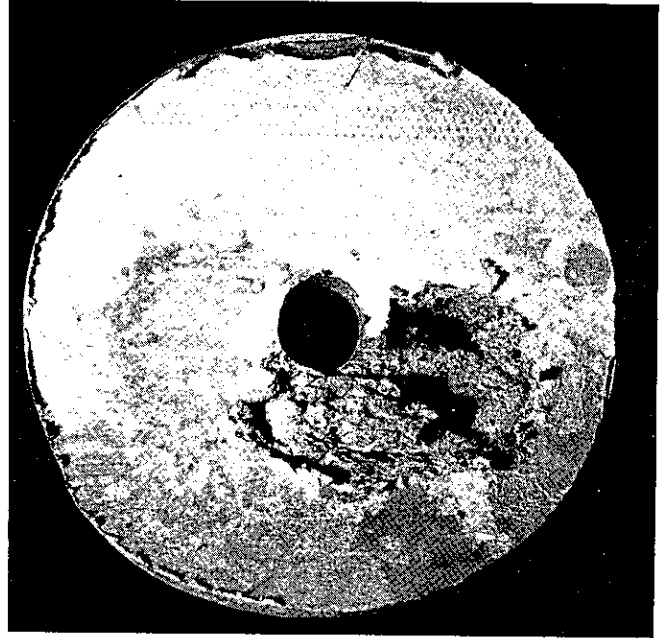
34-Feet from Outlet End, Center Pipe

Soil Side: Corrosion limited to the cladding  
layer, 0.0038 inch (not in  
cross section)

Water Side: Abrasion and corrosion limited to  
the cladding layer, 0.0038 inch

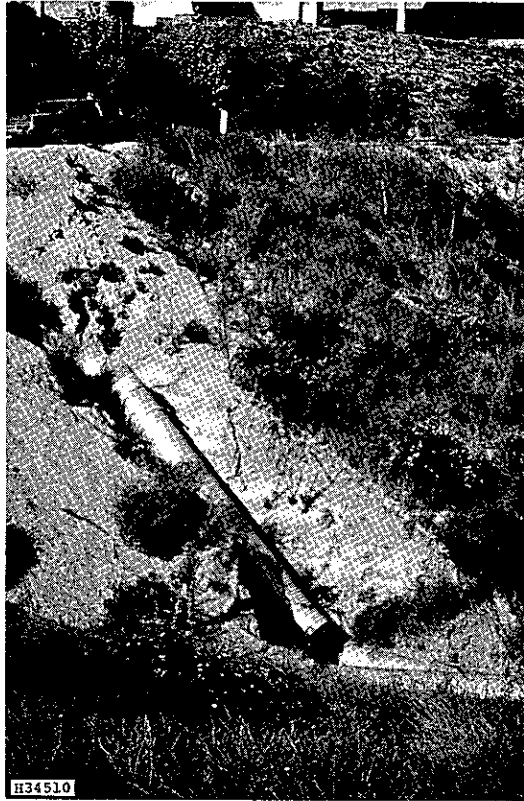
Soil Side: Slight surface etch,  
no measurable attack

Water Side: No attack

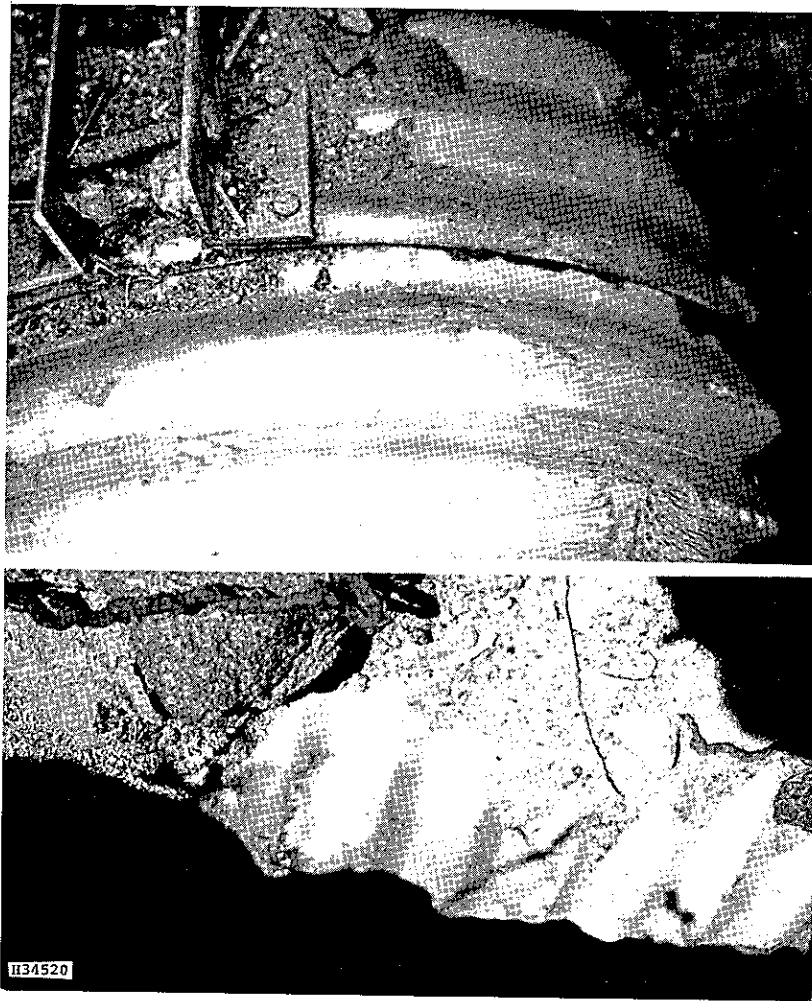
SITE #78-19      Riverside Co., Rancho California, De Los  
Caballos Rd., 0.15 Miles N.E. of Hwy 79  
(Site #70)

Soil Side: Attack limited to the cladding  
layer, 0.003 inch

Water Side: Staining, no measurable attack
